RHINO
CARBON FIBER
REINFORCEMENT PRODUCTS

CFRP CASE STUDY

CRACK REPAIR & CONFINEMENT

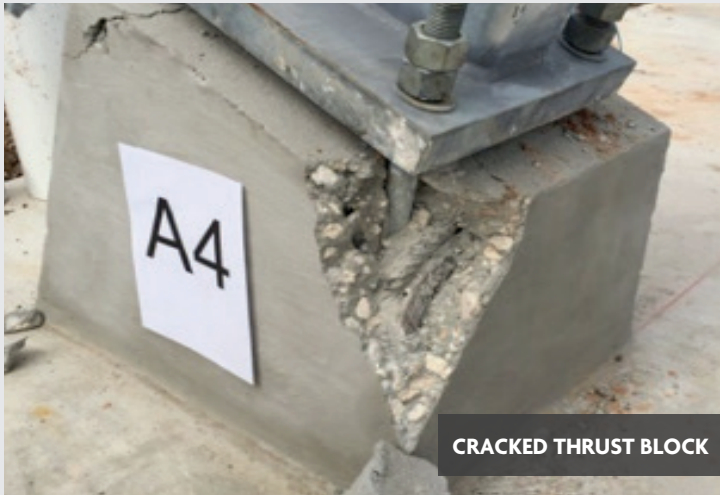
During the erection of the arches, the base plates had to be slid over anchor bolts that were cast into the thrust blocks and some cracking occurred around the anchor bolts on a few of the thrust blocks.

CRACKED THRUST BLOCK

The Gadberry Construction Company worked with The City of Houston's structural engineers to come up with the appropriate solution for the thrust block repairs. They determined that the best solution was to first inject the thrust blocks with **RCF™ Structural Epoxy Injection Resin**, and then wrap the blocks with 560 GSM, 24" wide **Rhino Carbon Fiber™ CFRP (Bidirectional)** applied with **RCF™ Saturant-Adhesive Epoxy**. The Gadberry Construction Company hired Olshan Foundation Repair Co. of Houston, LLC to complete the repair.

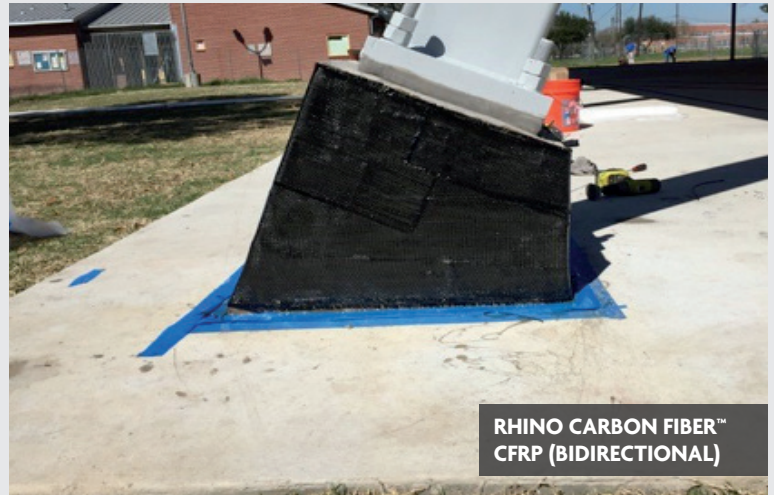
RHINO CARBON FIBER™
CFRP (BIDIRECTIONAL)

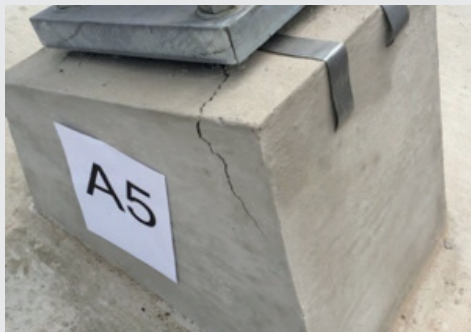
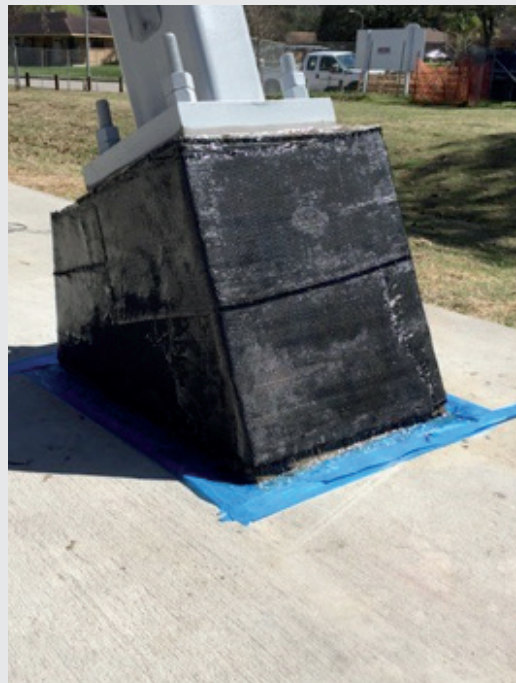
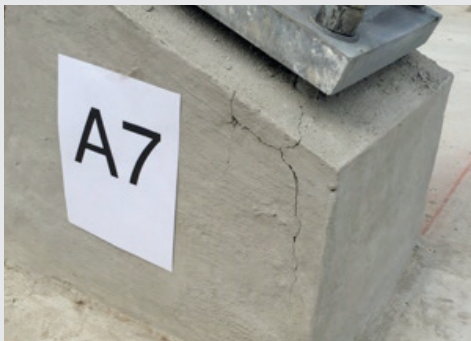
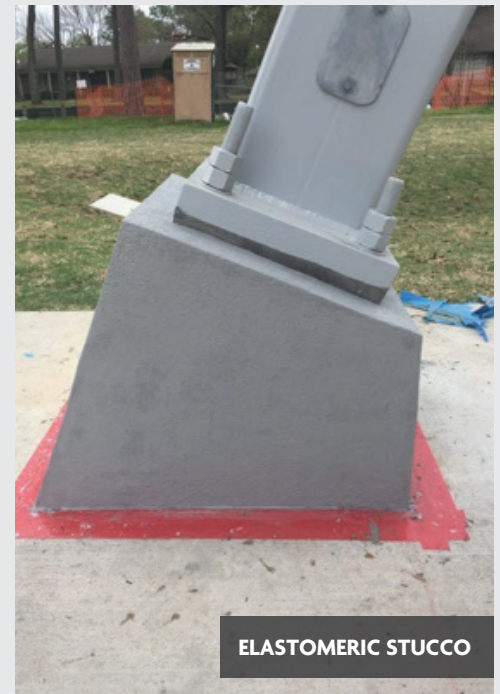
ELASTOMERIC STUCCO

After the CFRP installation per sub paragraph 2 of Item 786 of the standard, the contractor had to provide appearance coating recommended by a CFRP system manufacturer to protect the CFRP from ultraviolet radiation, and match color of the protective appearance coating to adjacent concrete. Elastomeric stucco was used to protect the CFRP and give the City a maintenance free coating that would not crack over time.
